**NMR PIPETECTOR Scientific Report (No.11)**  
**Anti-Corrosion Application,**  
**FUJIFILM IMAGING Co., LTD. DPE Factory**  
**To stop corrosion and prolong life of water pipe**

**43 Years Old Steel Galvanized Pipe for Drinking Water is Still Working without any problems, such as, water leak or colored water problems**

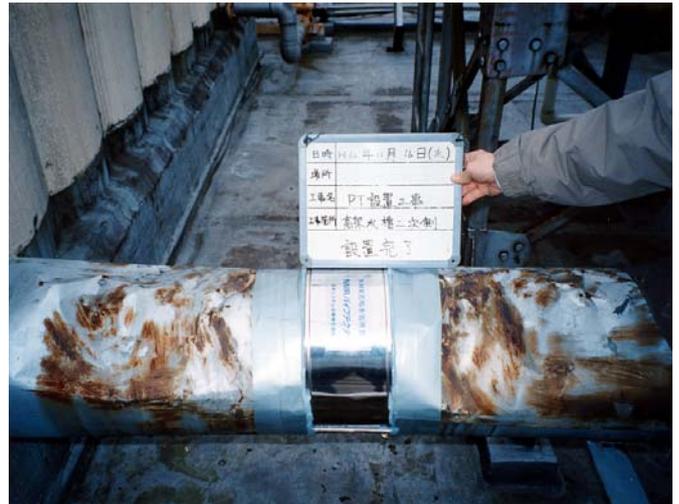
**On outlet pipe of the elevated tank**

Address	Choufu City, Tokyo, Japan
Building Summary	DPE Factory (35 years after being built)
Method of Water Supply	Elevated water tank method (Water Supply) Water consumption is 800ton a day
Installation Day	November 16, 2000
Installation Place Number of Installed NMR PIPETECTOR	On outlet pipe of elevated tank (SGP 200mm in diameter) NMR PIPETECTOR PT- 200DS × 1 unit

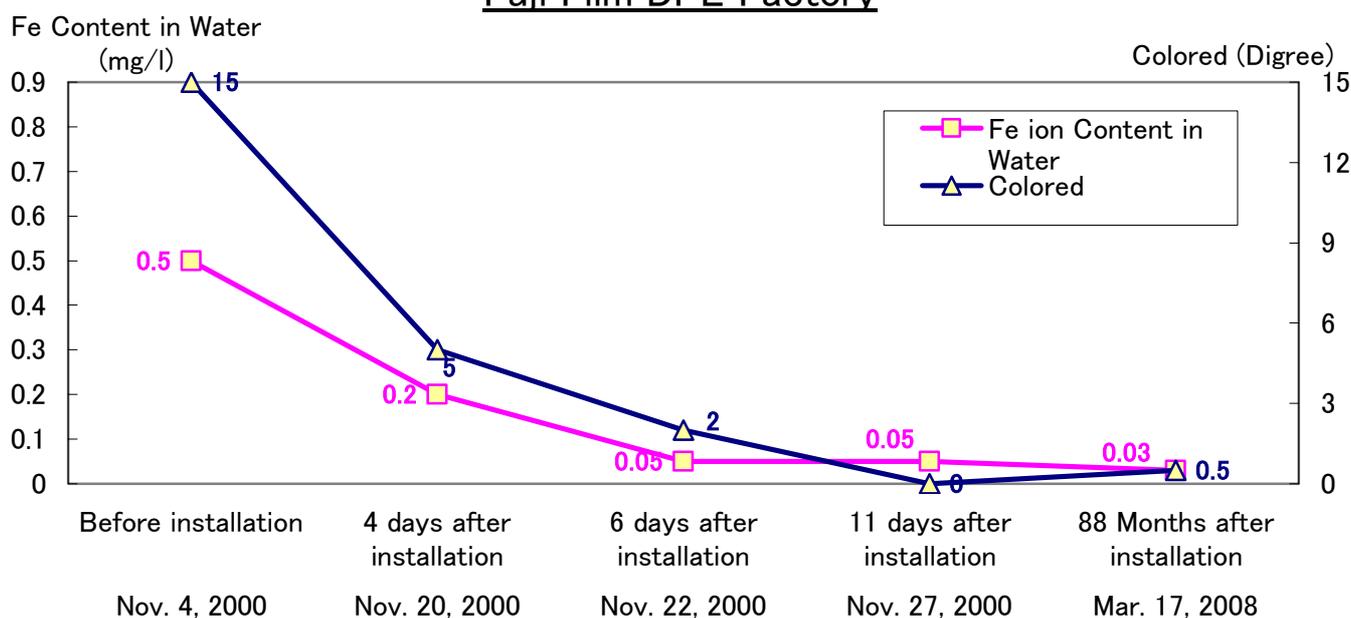
## ◆Change of Fe ion Content in Water and Colored Digree

### Fuji Film DPE Factory

**Before the installation** of **NMR PIPETECTOR**, Fe ion content of first water in the morning was 0.5 mg/l and colored of first water in the morning was 15 degrees, however, **6 days after the installation**, Fe ion content decreased to 0.05 mg/l and colored became 2 degrees.

88 months after the installation, the Fe ion content is less than 0.03mg/l, so these data show that the outflow of corrosion was completely stopped. Since that, corrosion has not flowed out any more.

Before installation Nov. 4, 2000	4 days after installation Nov. 20, 2000	6 days after installation Nov. 22, 2000	11 days after installation Nov. 27, 2000	88 Months after installation Mar. 17, 2008	Government regulation (Japan)
Fe ion Content in Water (mg/l)	0.5	0.2	Less than 0.05	Less than 0.05	Less Than 0.03	Less than 0.3 mg/l
Colored (degree)	15	5	2	0	Less than 0.5	Under 2 degrees
