NMR PIPETECTOR Installation Report
Anti-Corrosion Application,
Nissan Motor Co., Ltd. (Kyushu Factory)
(Cooling water)

To stop corrosion and prevent clogs in cooling pipe of welding robot

◆ Installation results

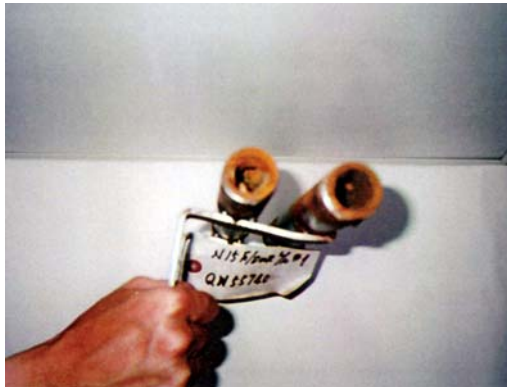
Before the installation

Inside of the cooling water pipe was seriously blockaded caused by corrosion. Therefore, the clogged cooling water pipe for the welding robot stopped the whole production line often.

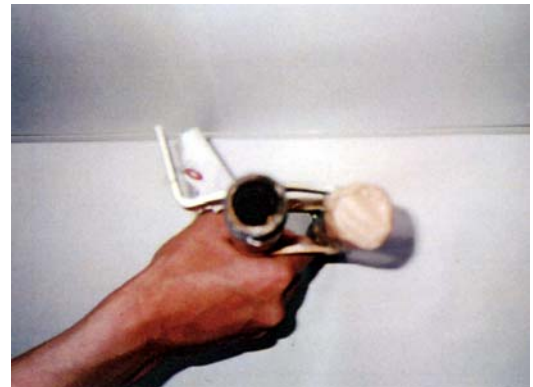
9 months after the installation

The corrosion was reduced to magnetite and clogs of the cooling water pipe disappeared. So, the whole production line did not have to be stopped.

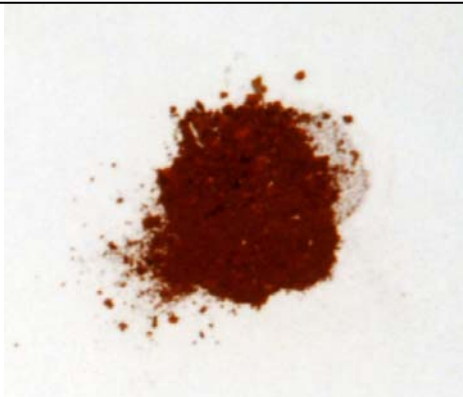
Before the installation
(Magnetite 4.0%)

The rust before the installation of NMR PIPETECTOR was red color.

According to the analysis done by Tokyo University of Science, before the installation of NMR PIPETECTOR, the ratio of magnetite as 4% while corrosion was 96%, but 9 months after the installation, magnetite became 43.6%. It proves that corrosion was reduced to magnetite which became film and protected the pipe.
