NMR Pipetector Test Report

By Ex-Hokkaido Industrial Research Institute Anti-Corrosion Device

Ex-Hokkaido Industrial Research Institute 1-5

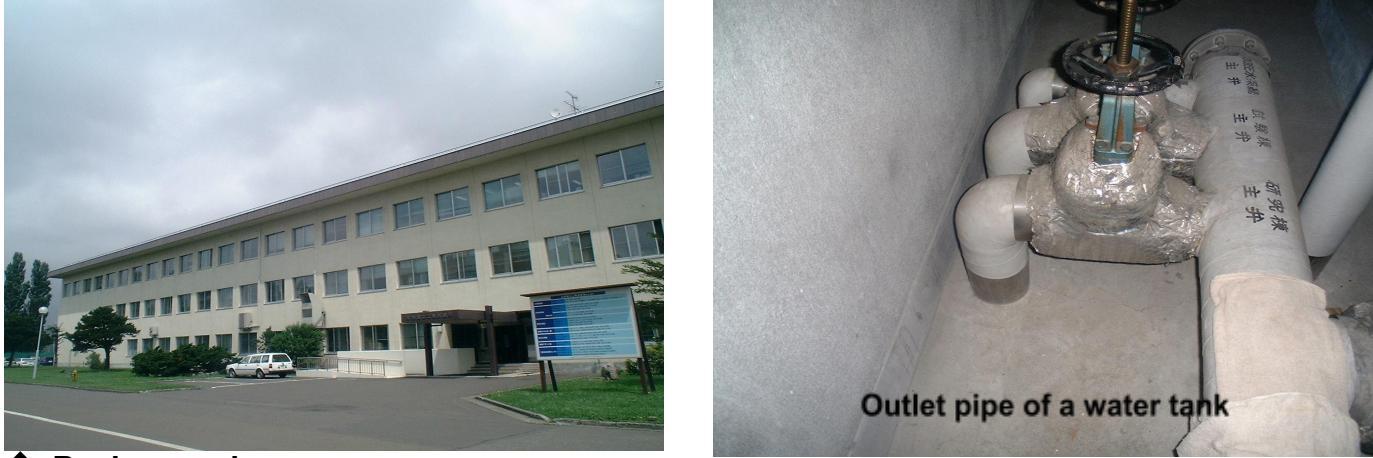
Appearance

Installation place, number	100-diameter galvanized steel outlet pipe of a water tank NMR Pipetector PT- 100DS × 1unit
----------------------------	---
